# BR Brake Van World Tour 13 Rebuild

Author: John Boyson

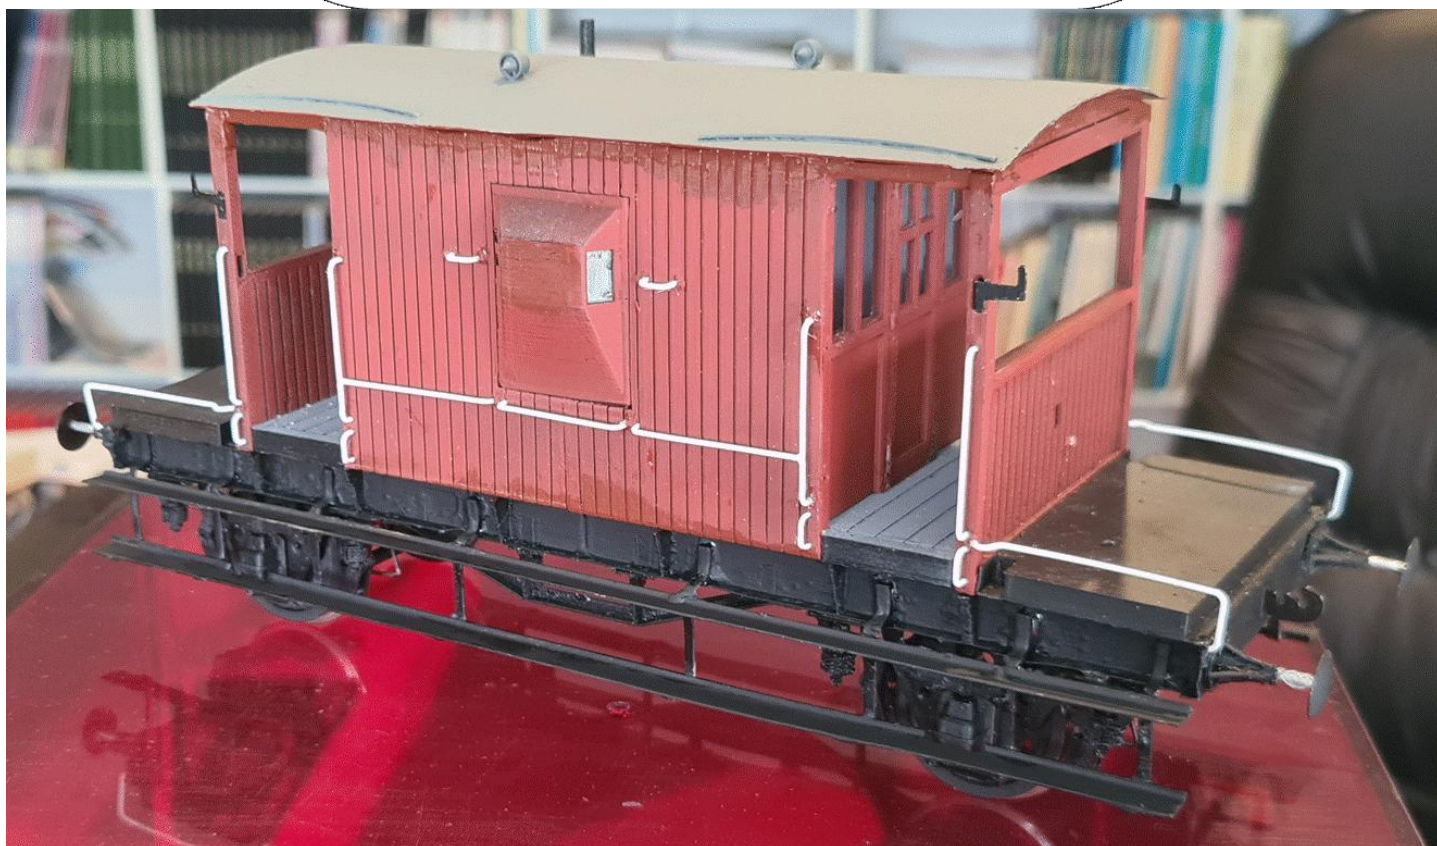
*The refurbished van ready for packing and posting.*

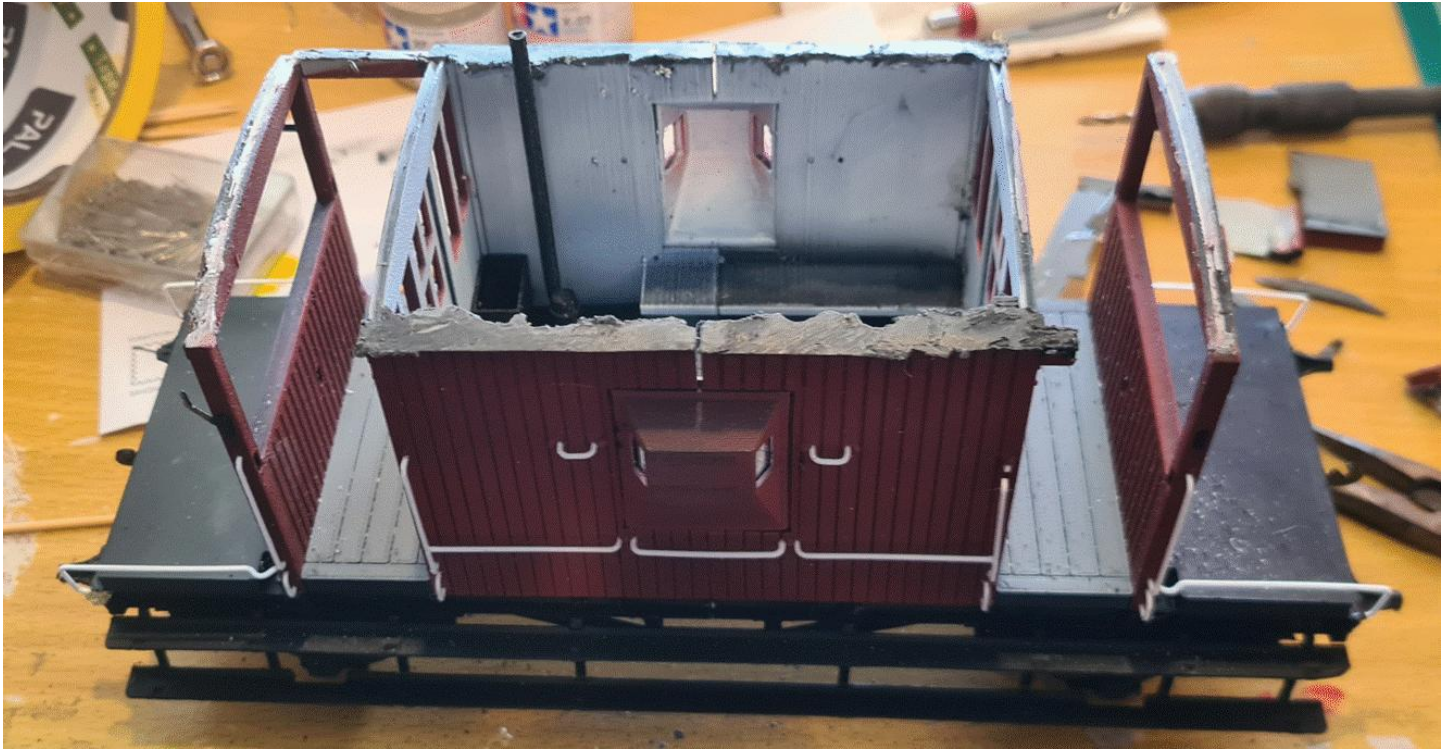
The first area tackled was the roof. This had been formed in two sections like the body. These had gradually been moving further apart (rather like the two islands of NZ!) This was distorting the body and underframe which was beginning to develop a hog. In addition, there were numerous glued cracks etc. and the whole thing looked really untidy. So, I bit the bullet and carefully removed it. The gap in the central joint of the two body sides is evident in the photo above. In removing the roof, I found out just how difficult working with PETG (the material used to form the prints) is compared with the ABS like resin I am more used to. It really is awful stuff (sorry Tref!). Despite my attempts at care, three of the four veranda beams have snapped off during the removal. In the end, the only way to get the roof off was with the Dremel since hand tools barely touched the PETG.

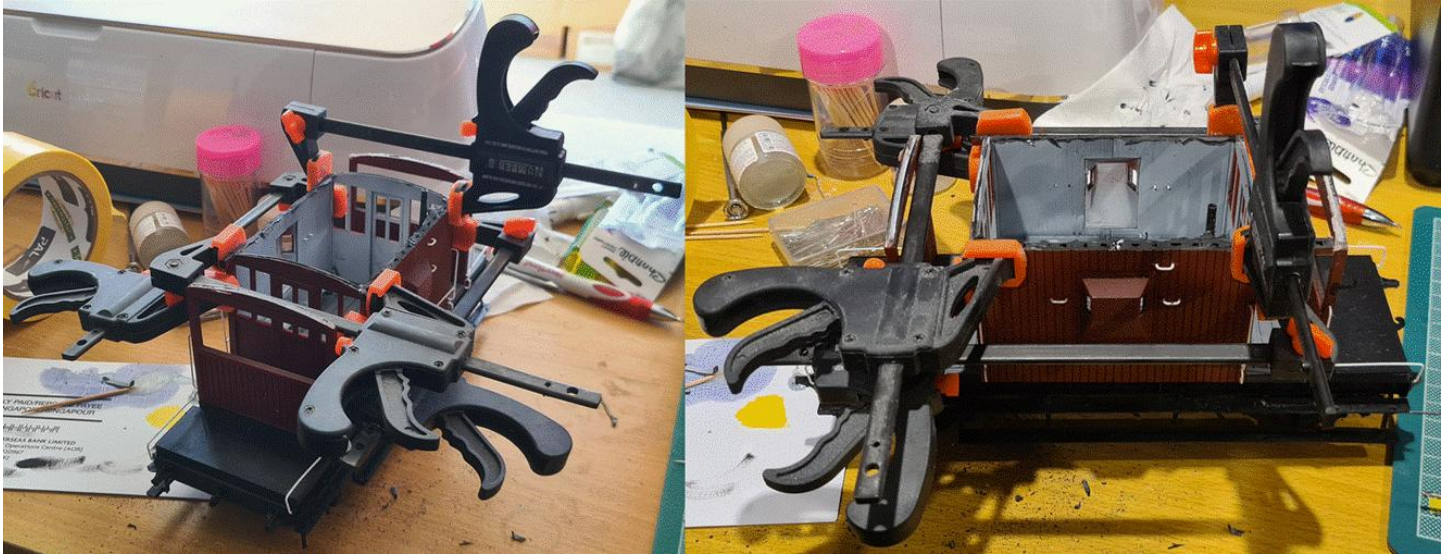
After all this painful surgery, the first task was to straighten the body and glue the two halves together. Here they are being forced together with clamps whilst the glue sets.

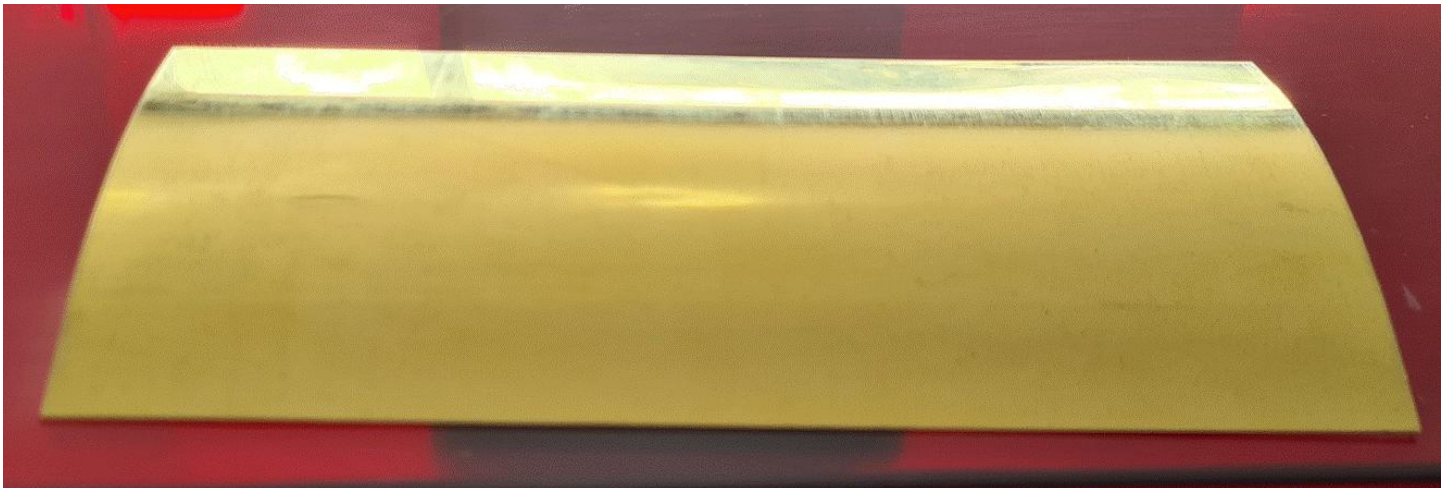
The new roof.

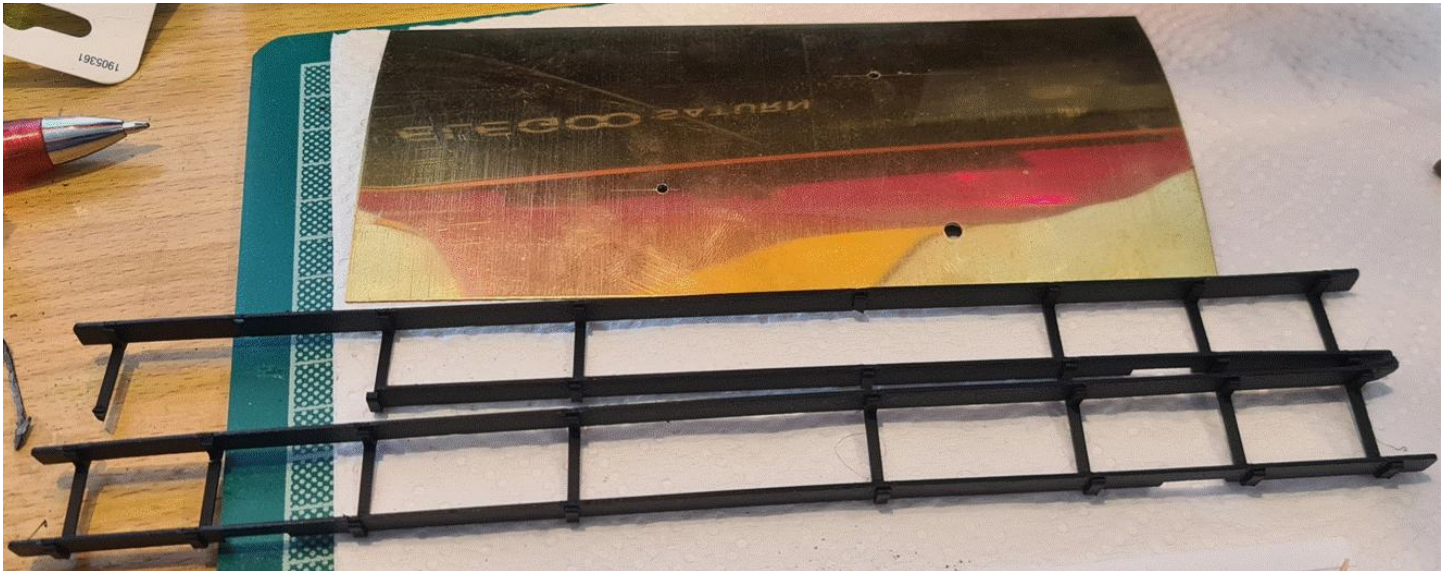
The new roof with holes drilled in for the chimney and ventilators together with the old steps. These are really fragile and bendy. Not ideal for a life on the road.

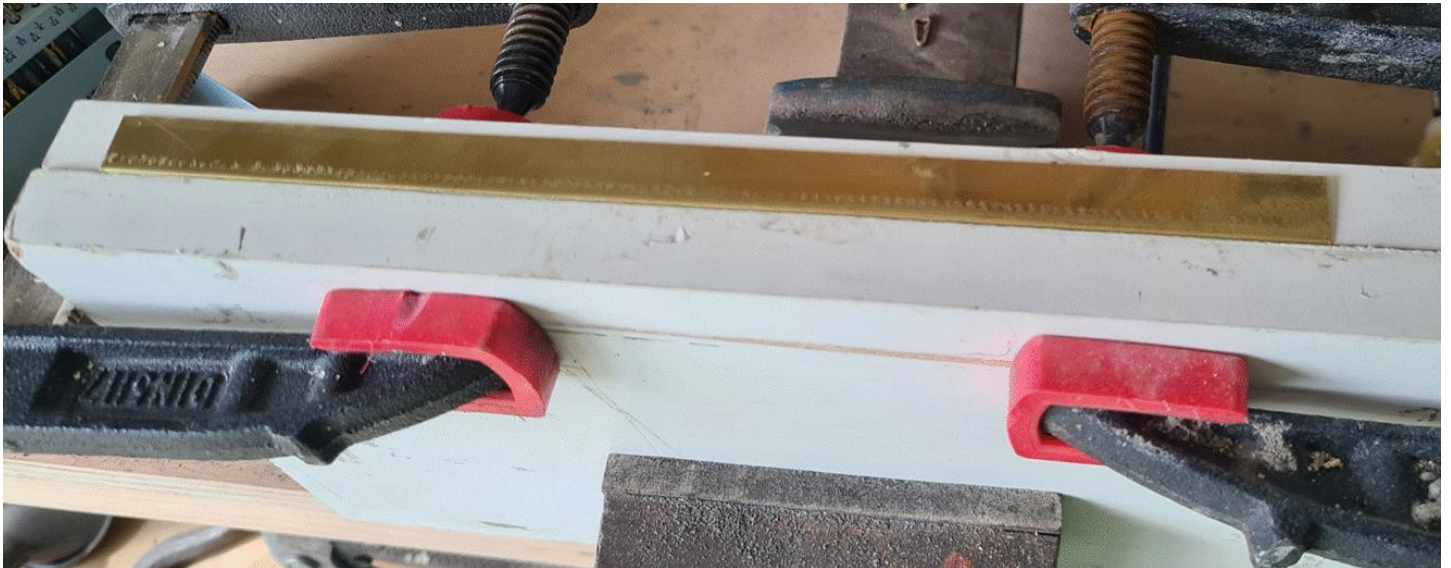
New steps being formed.

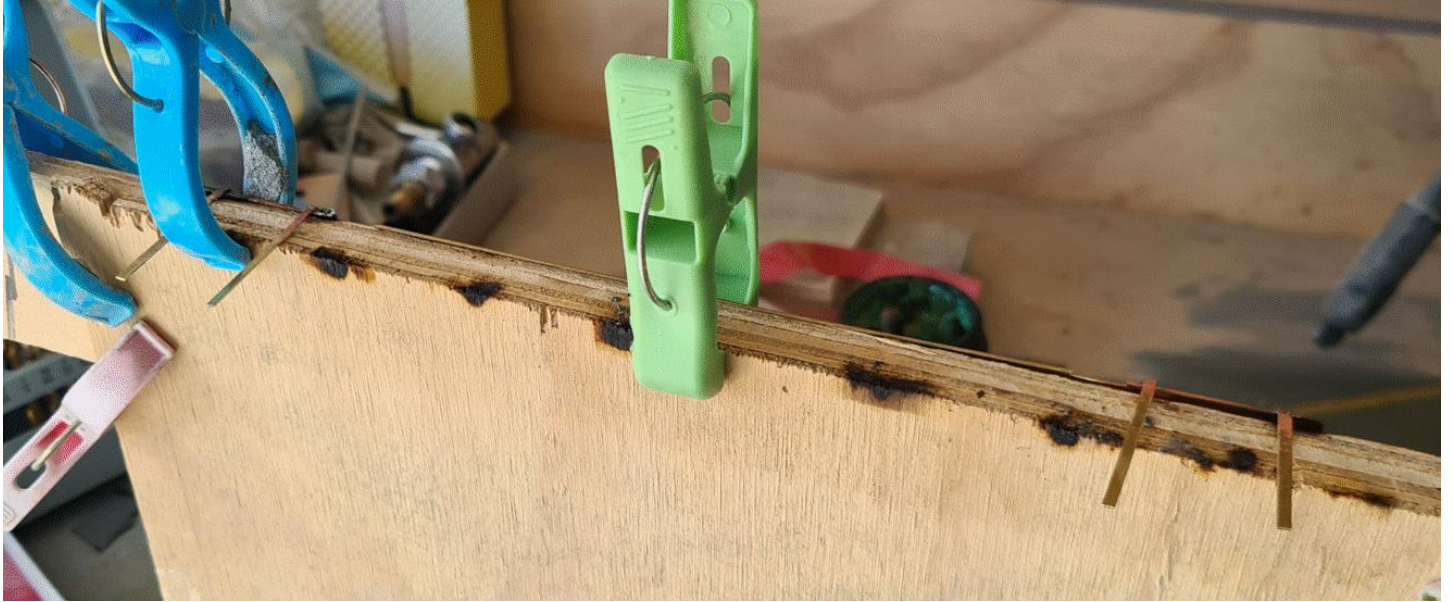
Connecting straps being soldered in place.

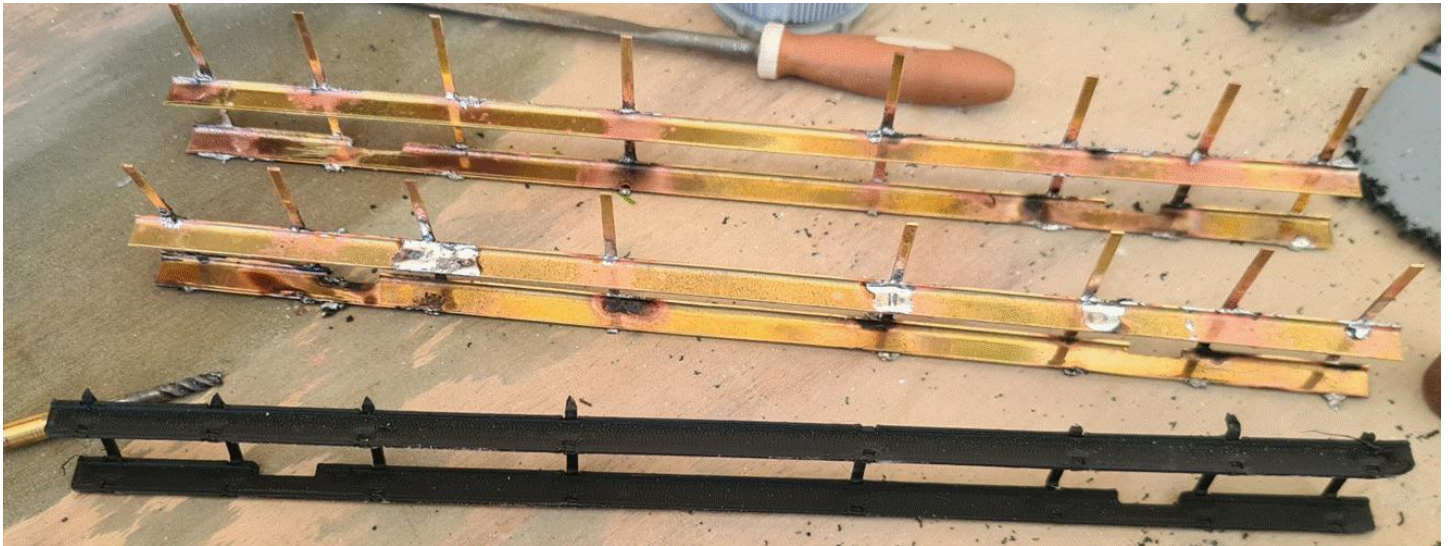
Completed steps ready for finishing with an old set in the foreground.

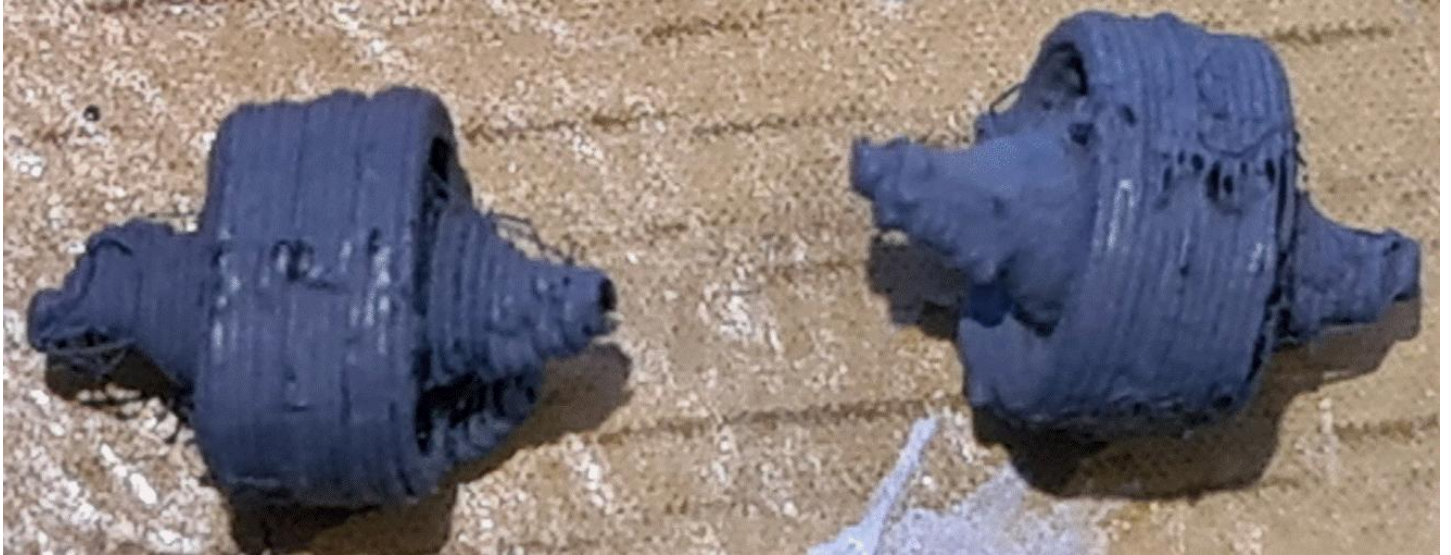
A rather cruel shot of the original roof ventilators.

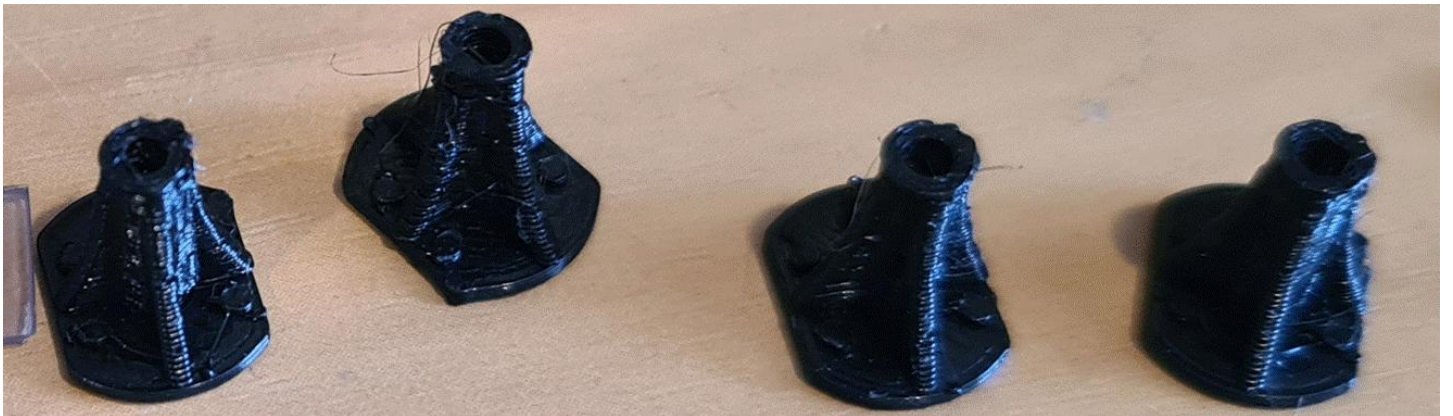
Every buffer head and shank had also disappeared. Fortunately, there were sufficient headstocks in the spares box to allow me to remove the originals and use these.

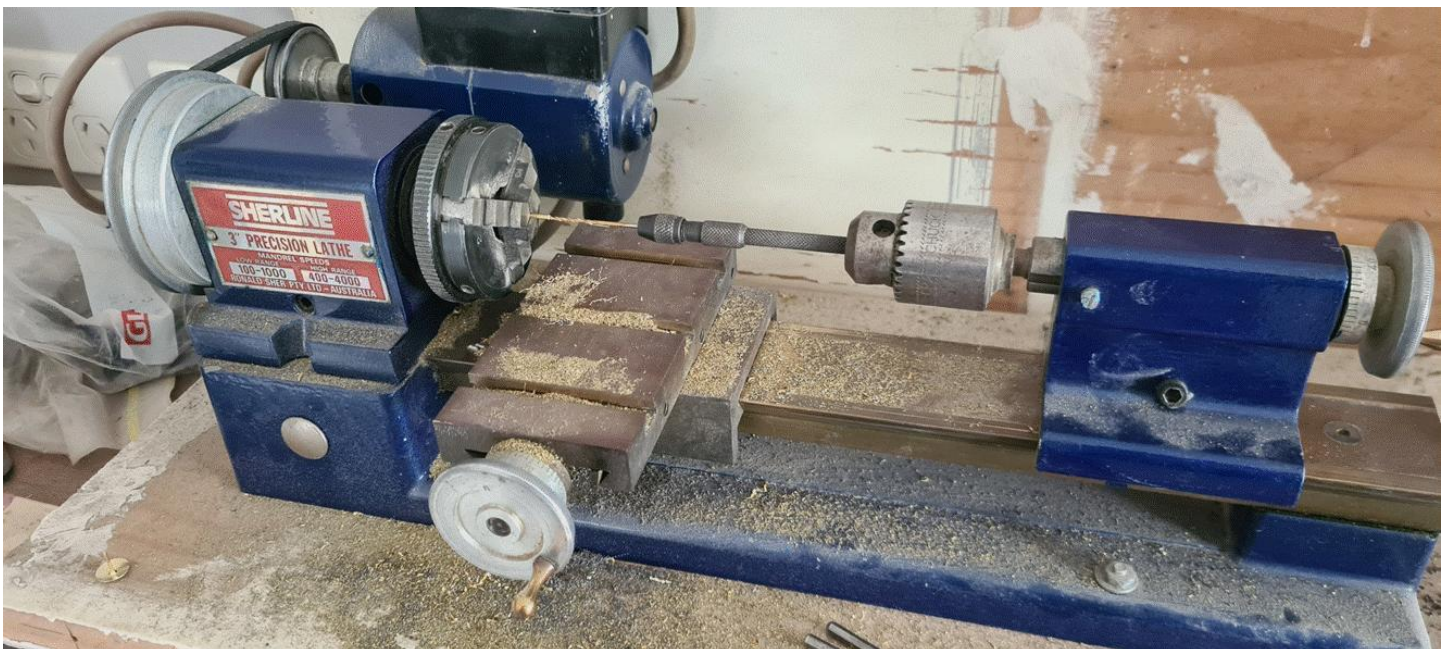
Being particularly vulnerable, I elected to make new shanks and buffer heads from brass. Here a section of tube being opened out to allow the head (a brass drawing pin) to be fitted. N.B. Whilst the lathe was used for the

operation, I did not power it up. Instead, I turned the headstock by hand and gently fed the centre drill in also by hand to ensure that there was no damage.

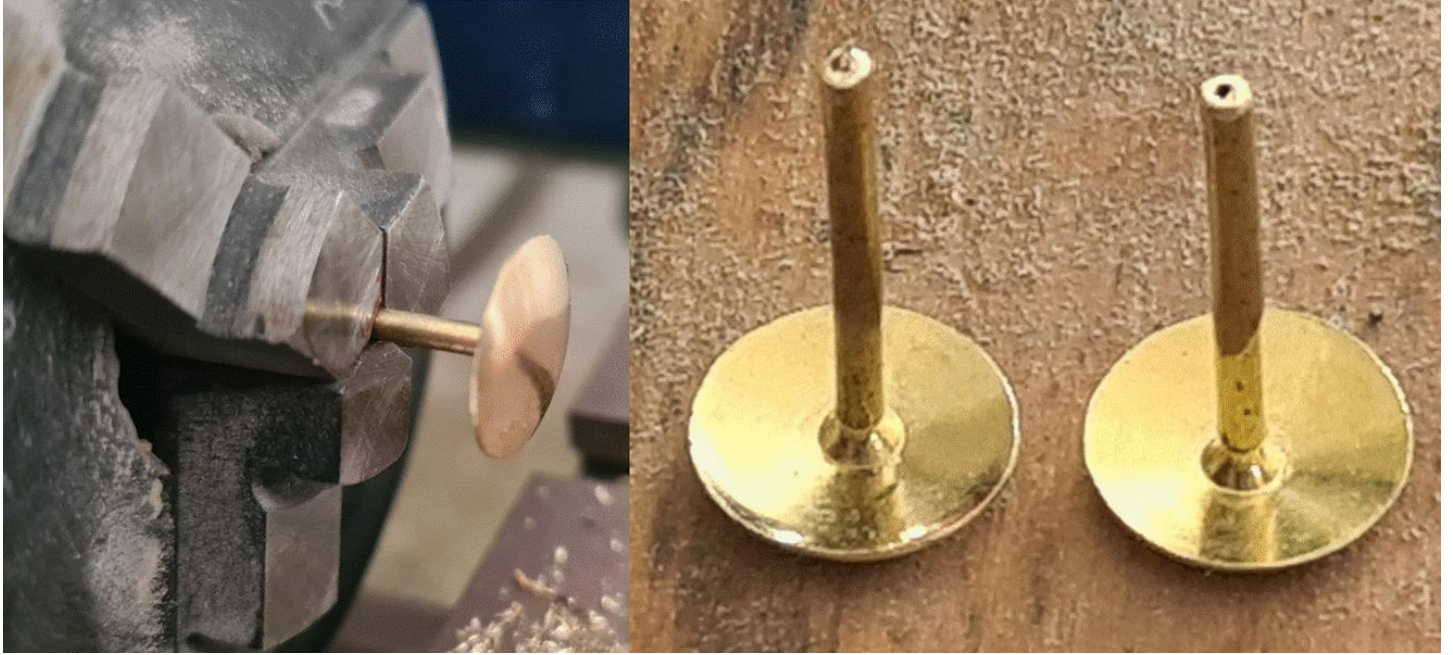
The prepared buffer heads. N.B. Brass drawing pins make great wagon buffer heads.

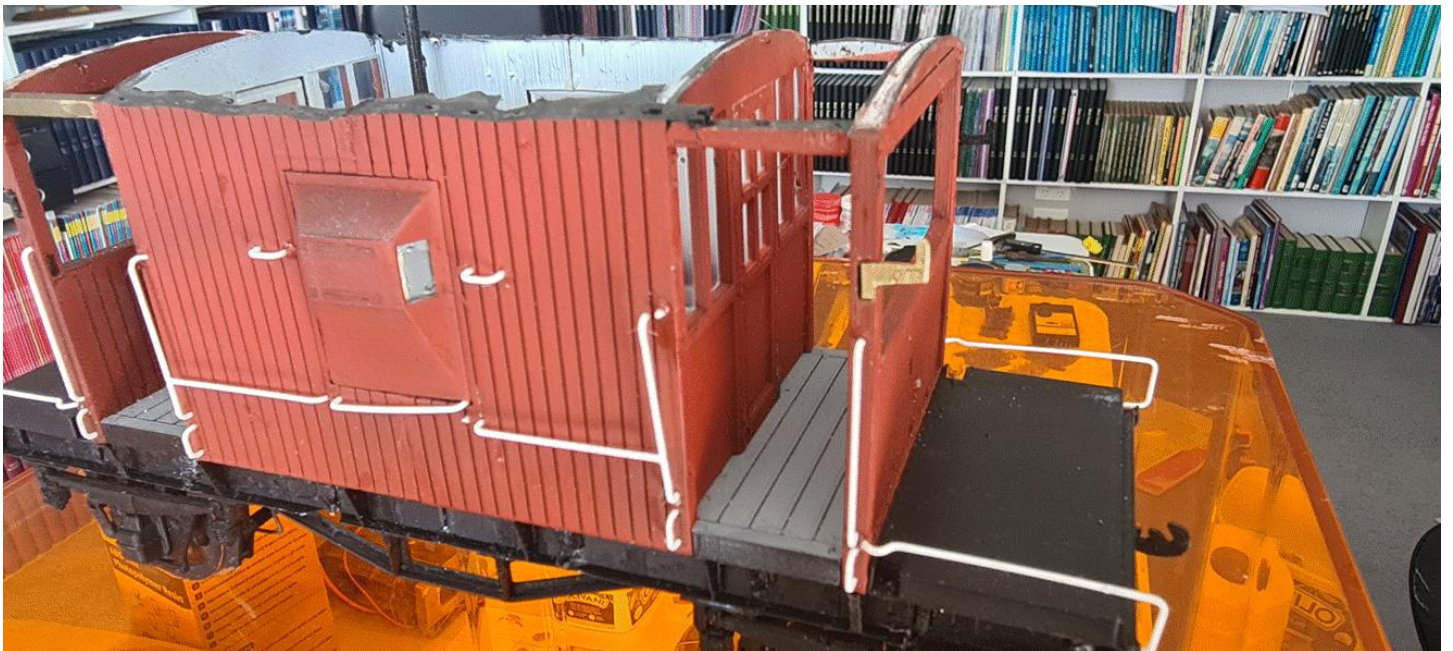
One of the enhancements made, was to fit glazing to the windows which had previously been open. Note also the damaged handrails which are likewise plastic. If I had more time I would have made up metal rails but since I was on a deadline, I simply glued the rails back in place. Maybe a job for the future. Note also the brass lamp iron on the top right where one of the plastic originals had gone AWOL.

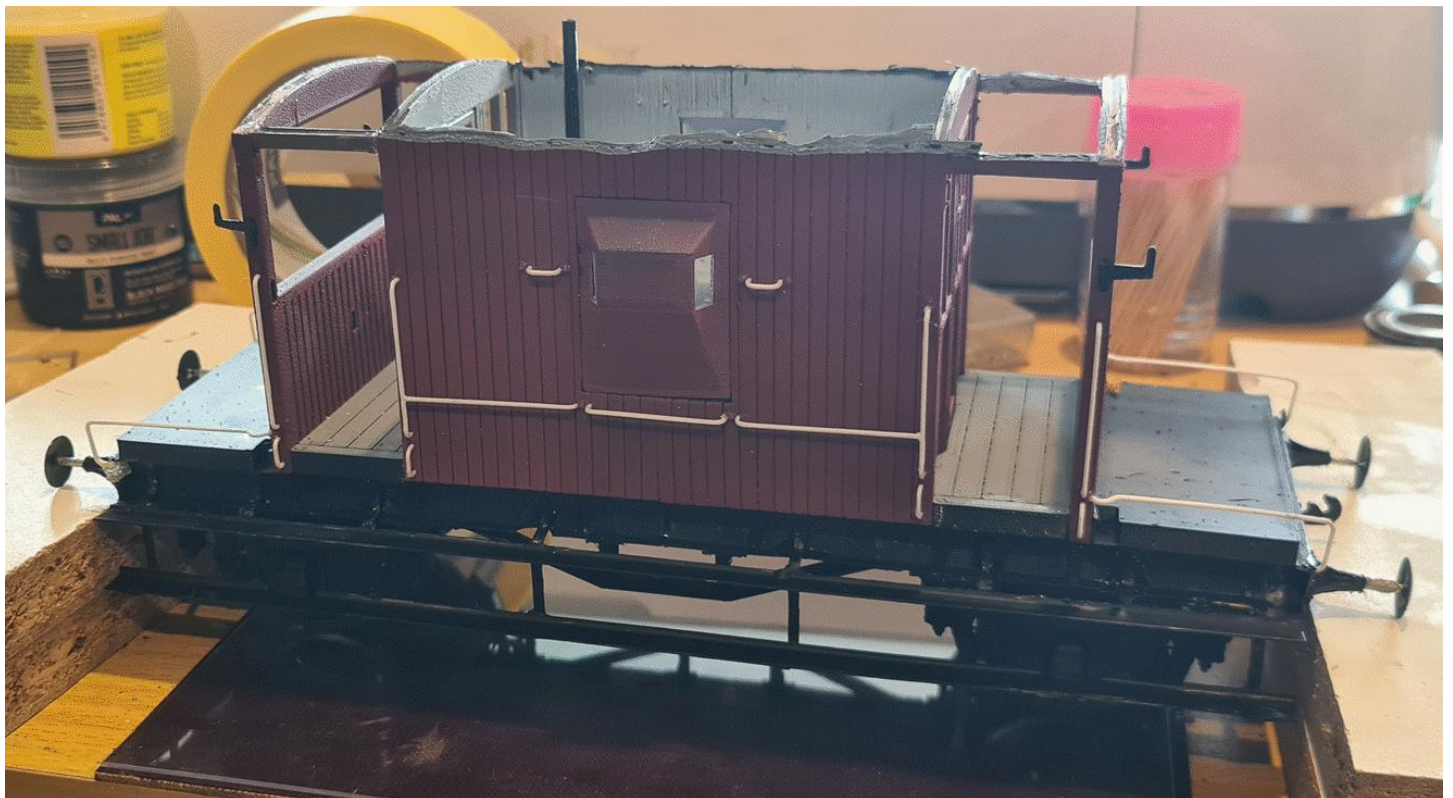
One of the footsteps glued in place and likewise, the buffers. The buffers are being supported by the wooden blocks on either side of the van whilst the glue sets.

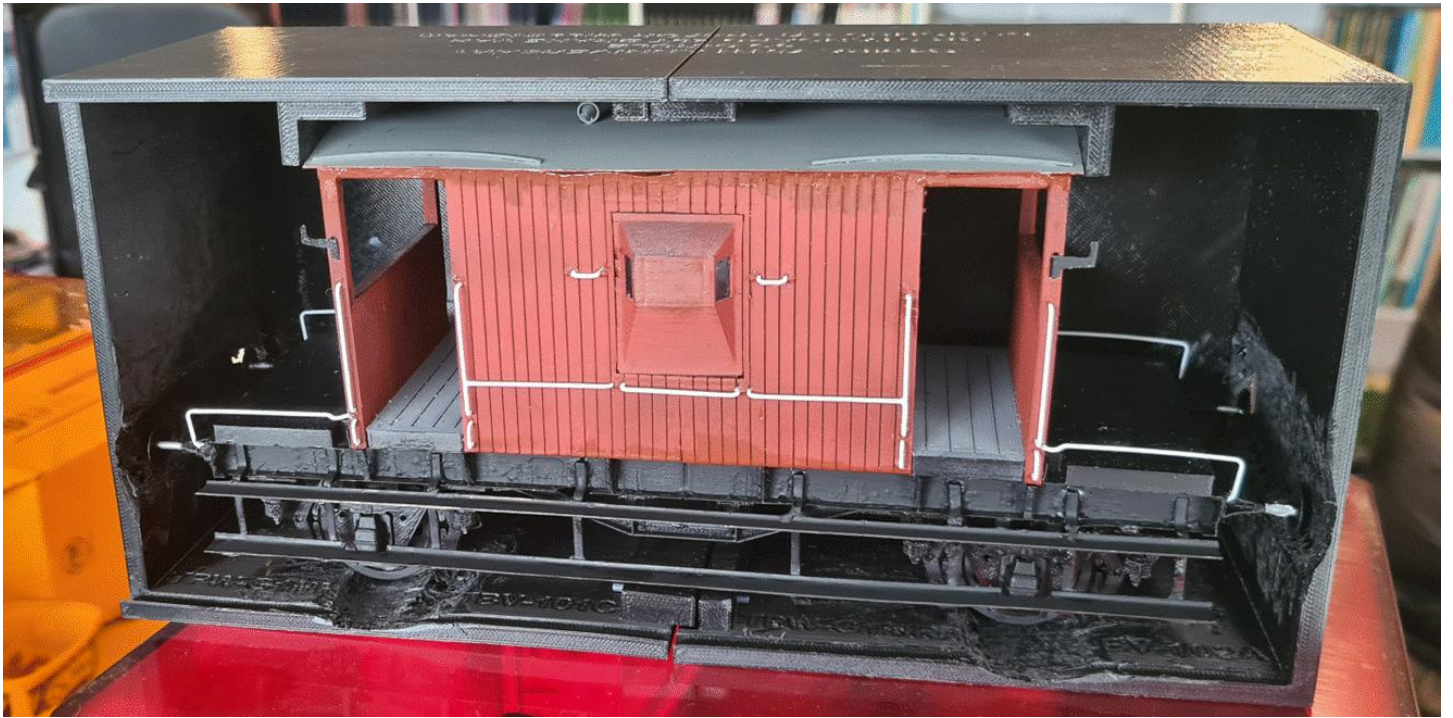
And stowed in its box. Frustratingly, the box needed to have areas ground out to both accommodate the buffers and the wheels. These had always been tight before but now it simply wouldn't fit any longer.

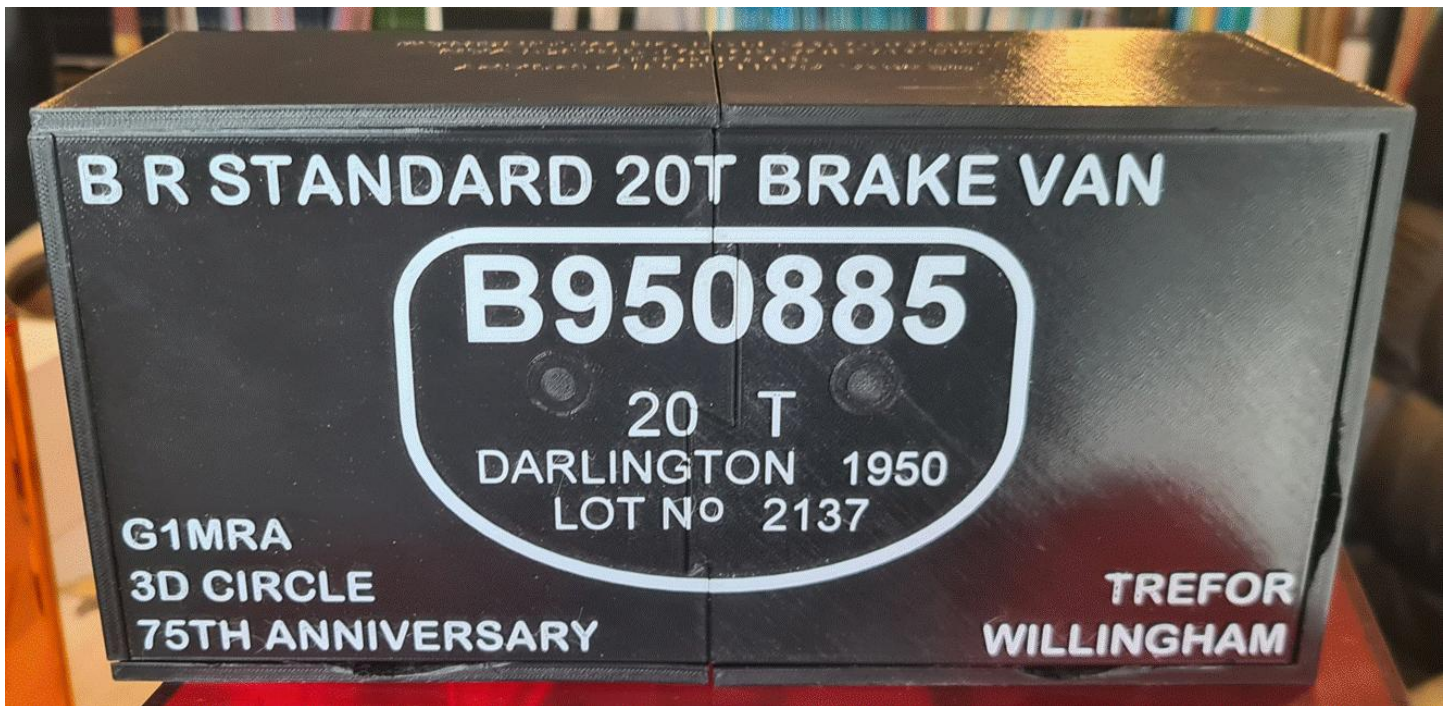
And packed ready for shipping to Tasmania.
